**APPLICATION:** Tiles Factory  
**LOCATION:** UK  
**DIFFICULTY:** Matched lengths  
**CHAIN TYPE:** Adapted Chain

# CASE HISTORY

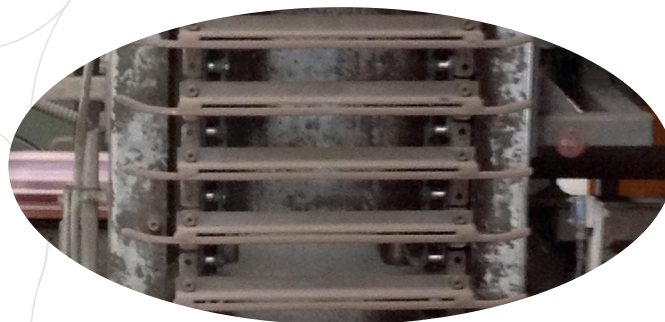
As four chains work in parallel, when one gets worn more quickly it regularly needed to be adjusted and to do so production had to be stopped so they could change the chain. We therefore proposed a set of four matched DELTA® chain, with the tightest tolerance possible.

The Delta® treatment prevented the chains from wear as no other treatment did. As the chains were in a matched set of four, they run perfectly together and the customer have had no issues with the chains wearing prematurely. These chains lasted over twice the life of the previous chains! That's why our chains are installed on all the customer's machines.
